Manhole Inspection Summary

Manhole # S37CC1029MH

Location Address: **3537 NEWLAND RD**

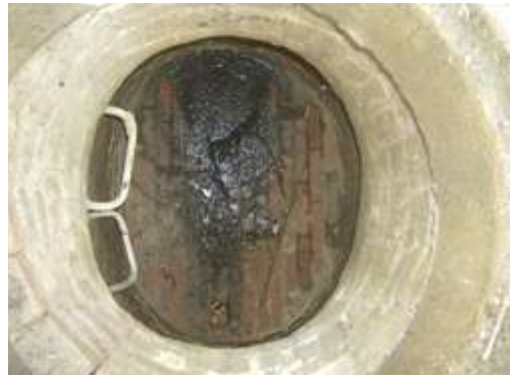
Top View

Channel debris.

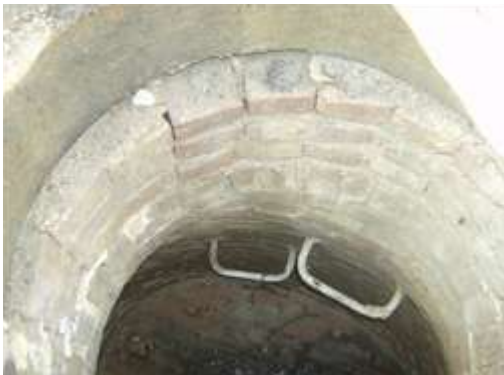
Defect

☒ **Leaks**

Condition: ☐ Sound ☐ Cracked ☐ Root Intrusion ☐ Loose Brick ☒ **Deteriorated**

Infiltration: ☐ None ☒ **Joint** ☐ Cracks ☐ Mortar ☐ Roots ☒ **Wall**

Infiltration: ☐ None ☐ Joint ☐ Cracks ☐ Mortar ☐ Roots ☒ **Wall**

Frame leaks. Frame offset. Adjustment deterioration and infiltration. Barrel infiltration.

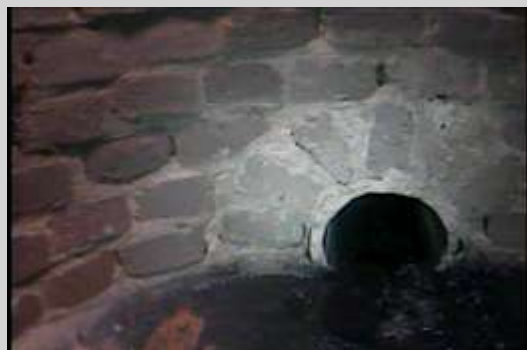
Pipe Out @ 12 O'Clock

Deposits: ☐ None ☐ Mud ☒ **Gravy** ☒ **Debris** ☐ Grease

Silt Depth: **0.5** (in.)

Deposits Extent: **Light**
